**Flood Control Project Maintenance
Levee Inspections**
LMA District Cover Sheet
Spring 2011 Levee Inspection Results

Reclamation District No. 1660 Tisdale

Levee Inspection Report By Mile - Spring 2011

Waterway						Bank	Unit Miles	Inspection Start/End	Inspector
Unit No. 01 Sacramento River						Left	3.00	04/05/2011 04/05/2011	Bob Duffey

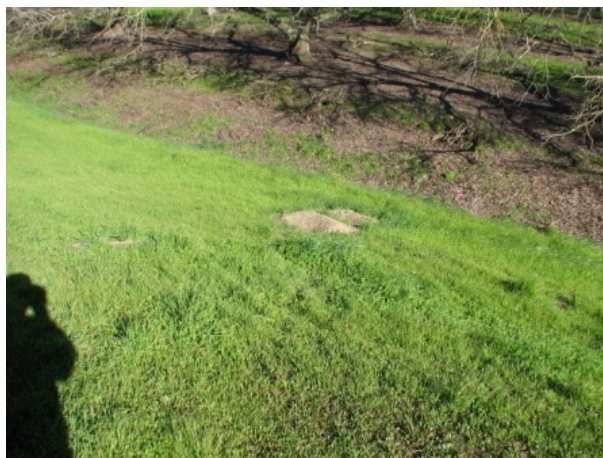
Levee Mile Report Line	1
Start Levee Mile	0.08
End Levee Mile	0.10
Location	Land Side
Category	Earthen Levee
Item	Animal Control

View of squirrel holes along the slope.

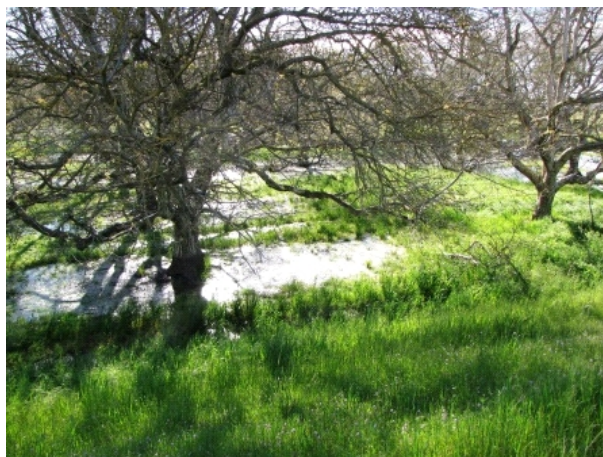
Levee Mile Report Line	2
Start Levee Mile	0.26
End Levee Mile	0.26
Location	Land Side
Category	Earthen Levee
Item	Seepage / Sandboils

View of the seepage along the toe.

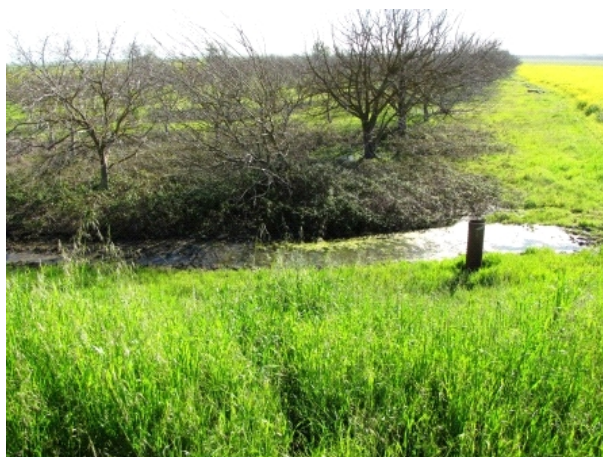
Levee Mile Report Line	3
Start Levee Mile	1.11
End Levee Mile	1.11
Location	Land Side
Category	Earthen Levee
Item	Seepage / Sandboils

View of the seepage along the toe.

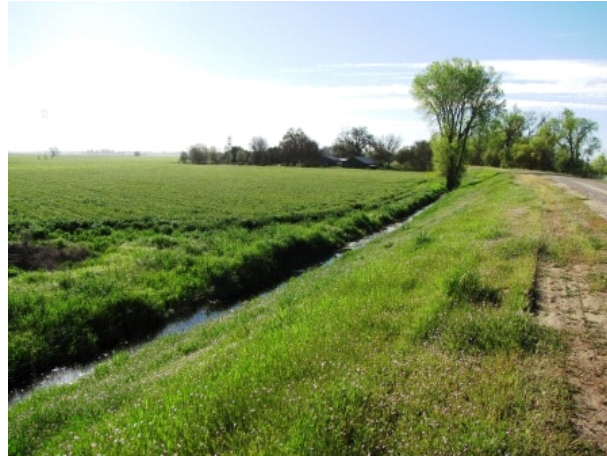
Levee Mile Report Line	4
Start Levee Mile	1.12
End Levee Mile	1.43
Location	Land Side
Category	Earthen Levee
Item	Encroachments

View of the AG ditch along the L/S toe.

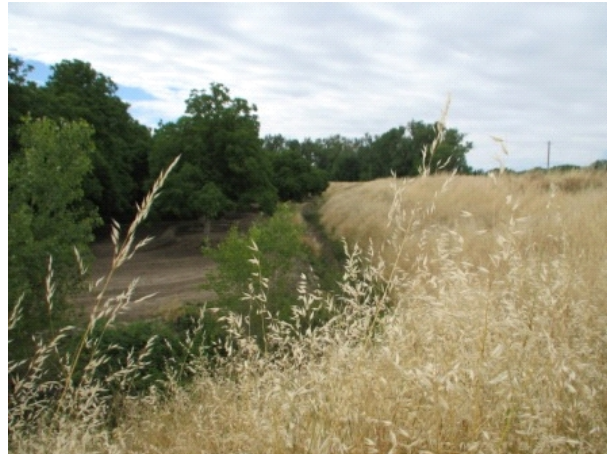
Levee Mile Report Line	5
Start Levee Mile	2.04
End Levee Mile	2.38
Location	Land Side
Category	Earthen Levee
Item	Encroachments

View of the large ditch along the landside toe.

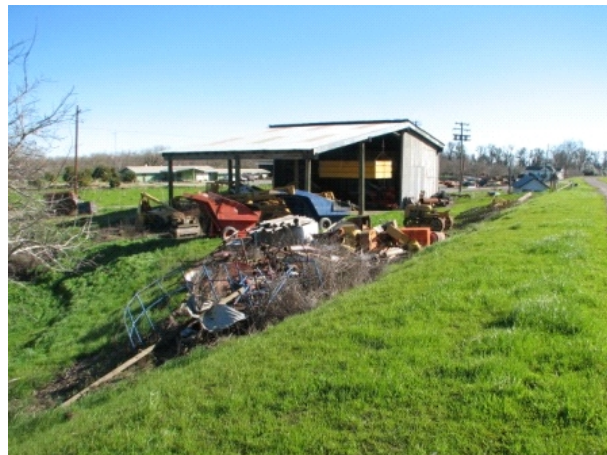
Levee Mile Report Line	8
Start Levee Mile	2.63
End Levee Mile	2.63
Location	Land Side
Category	Earthen Levee
Item	Encroachments

View of equipment along the slope.

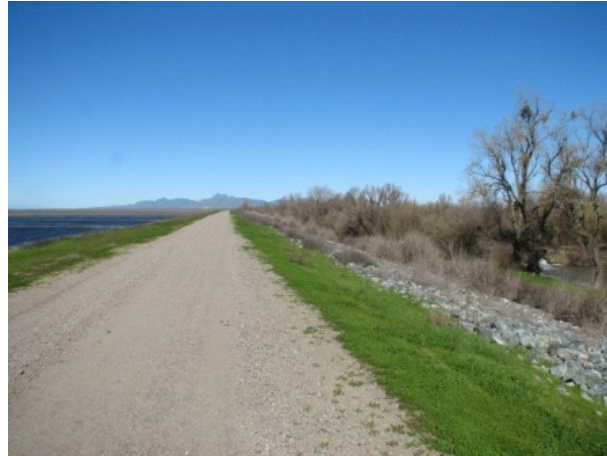
Levee Mile Report Line	1
Start Levee Mile	0.06
End Levee Mile	0.44
Location	Water Side
Category	Earthen Levee
Item	Trim / Thin Trees

View of the sprayed trees along the waterside slope of the levee.

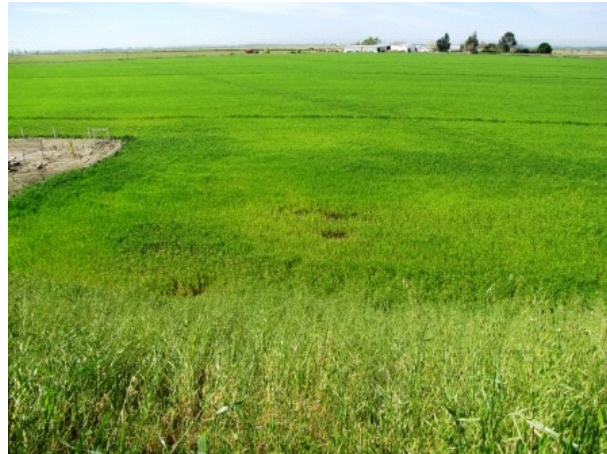
Levee Mile Report Line	2
Start Levee Mile	8.47
End Levee Mile	8.47
Location	Land Side
Category	Earthen Levee
Item	Seepage / Sandboils

View of the seepage along the L/S toe.
